Data Driven Approach to Improve Source Control Program

Improving Restaurant FOG Compliance

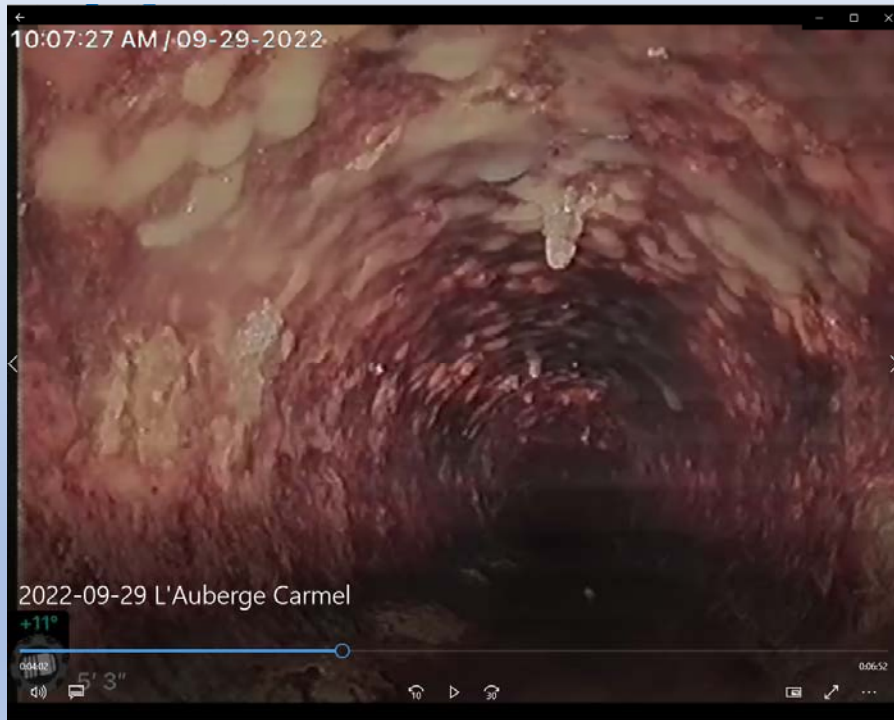
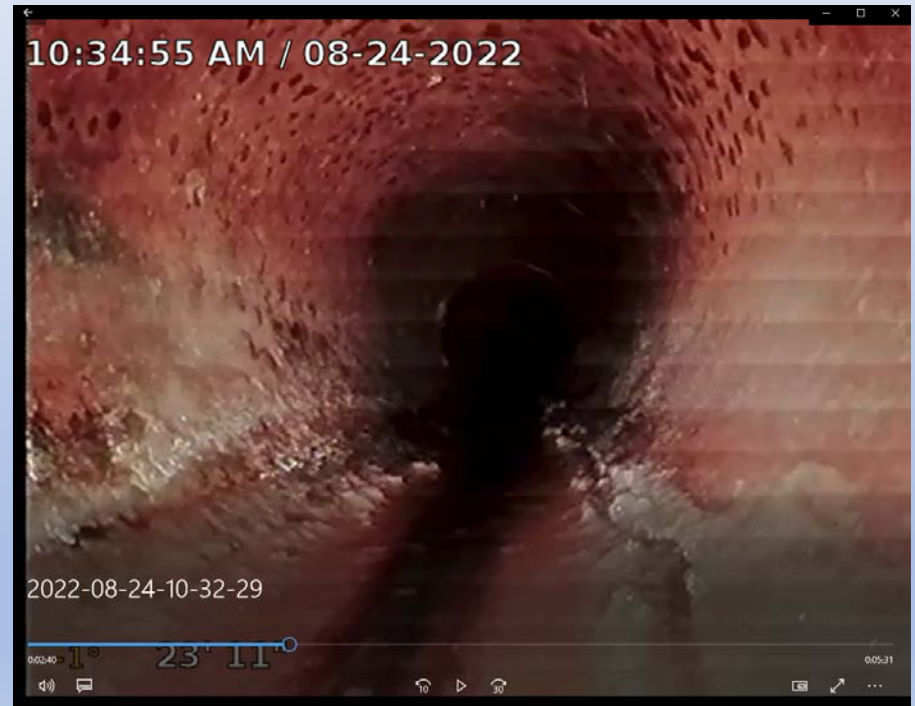
Example of Heavy and Light Grease Videos From Source Control Inspection

- Eight of the top 30 potential problem restaurants had no CCTV access
- CAWD's Plumbing and Pretreatment Ordinances require cleanouts
- 19 of the 22 laterals CCTV'd had Moderate to Heavy Grease
- All 30 grease interceptors were sized under 150 pounds

- Outreach to City of Carmel-by-the-Sea **and** Restaurant owners/managers regarding problem
- Outreach to the 19 Restaurants that had heavy grease in laterals and provide requirements to improve
- Need to put together a list of all restaurants that are missing cleanouts. Then send letter to property owner to rectify that issue.
