# Biological Resources Assessment

## Carmel Meadows Lift Station and Sewer Replacement

CARMEL AREA WASTEWATER DISTRICT, MONTEREY COUNTY, CALIFORNIA

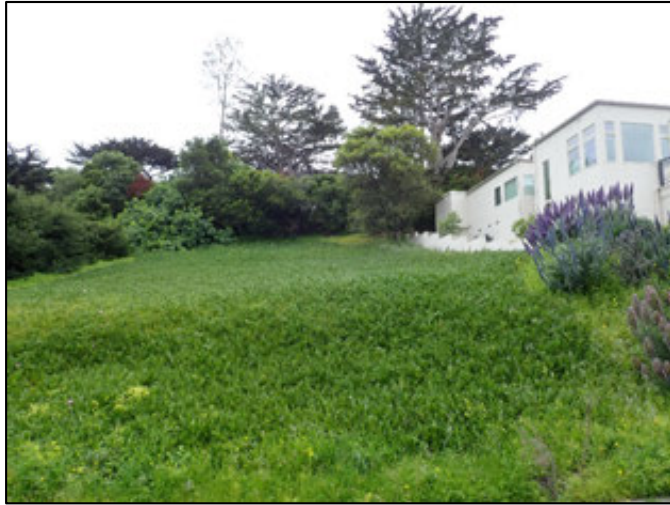
(A) Representative photo facing south of iceplant mats within the proposed staging area.

**Iceplant Mats.** Iceplant mats were observed in multiple patches throughout the Study Area between coast live oak woodland and houses where the iceplant (*Carpobrotus edulis*) had overtaken landscaping. The proposed staging area is also completely covered with iceplant mats. These mats are comprised almost completely of iceplant, although some mats also contains some ripgut brome.

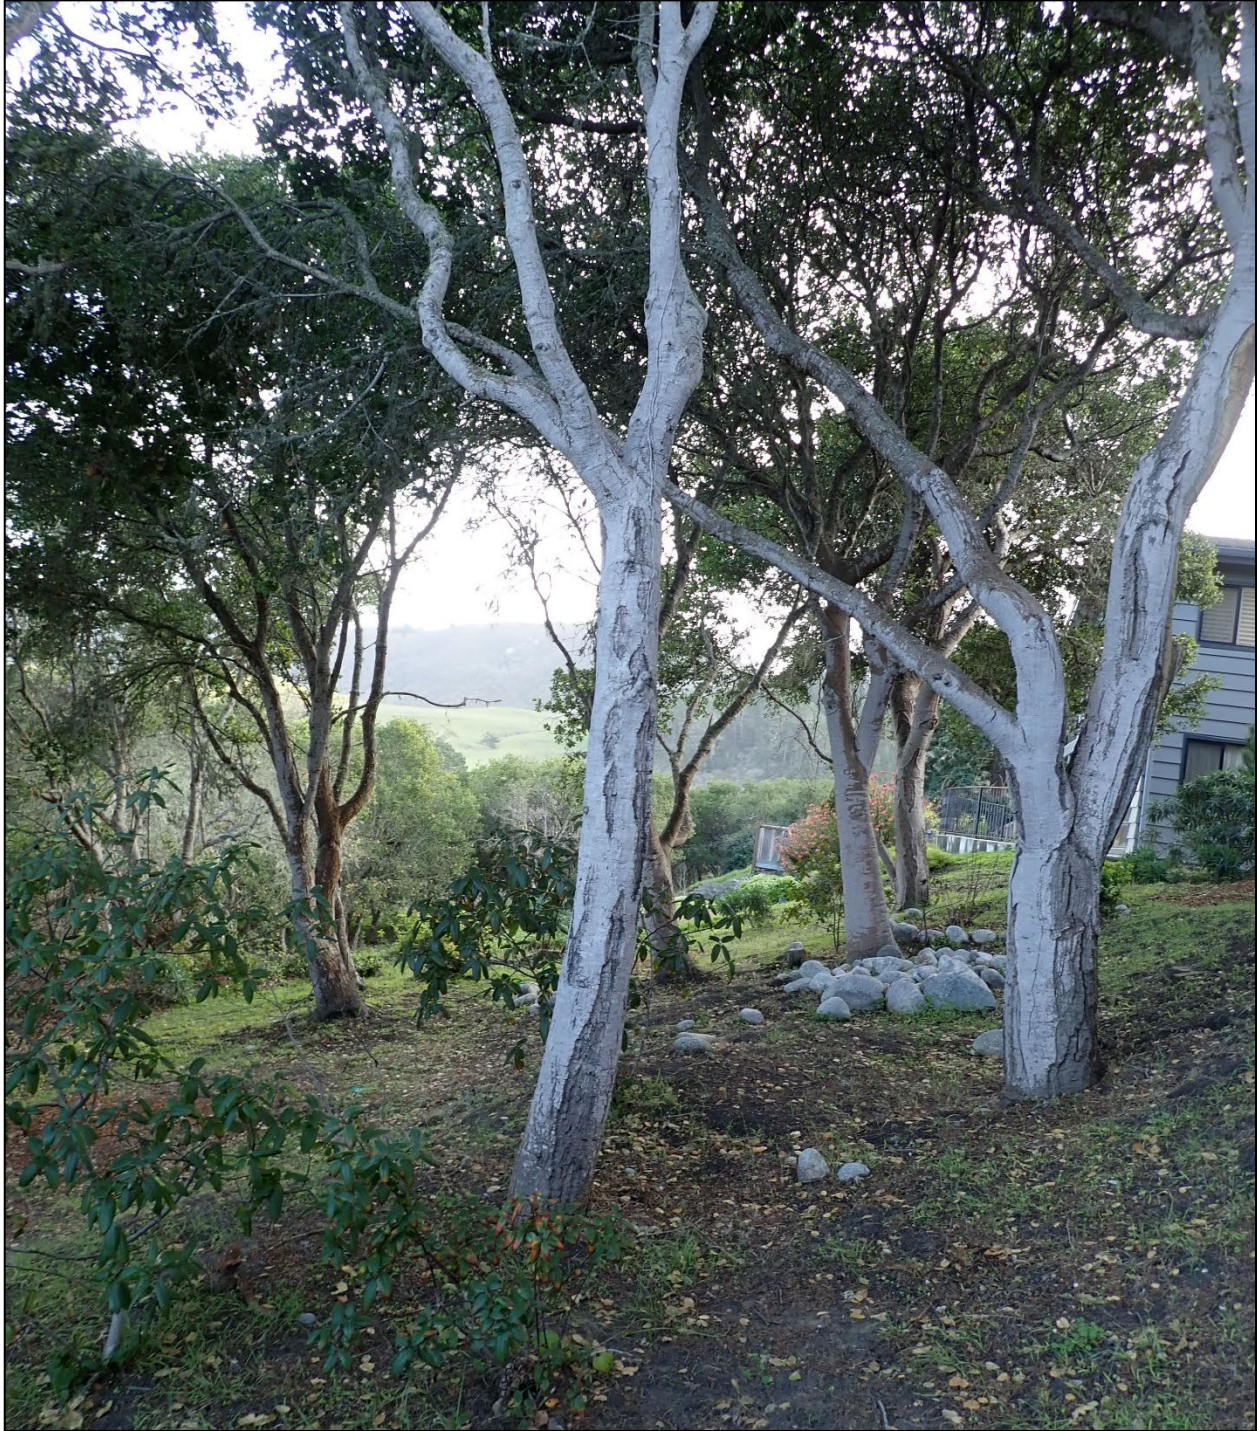
**Photograph 1.** Trees #382 - #387, protected coast live oaks, behind address 2905 Ribera Road. These trees are adjacent to the new sewer replacement.

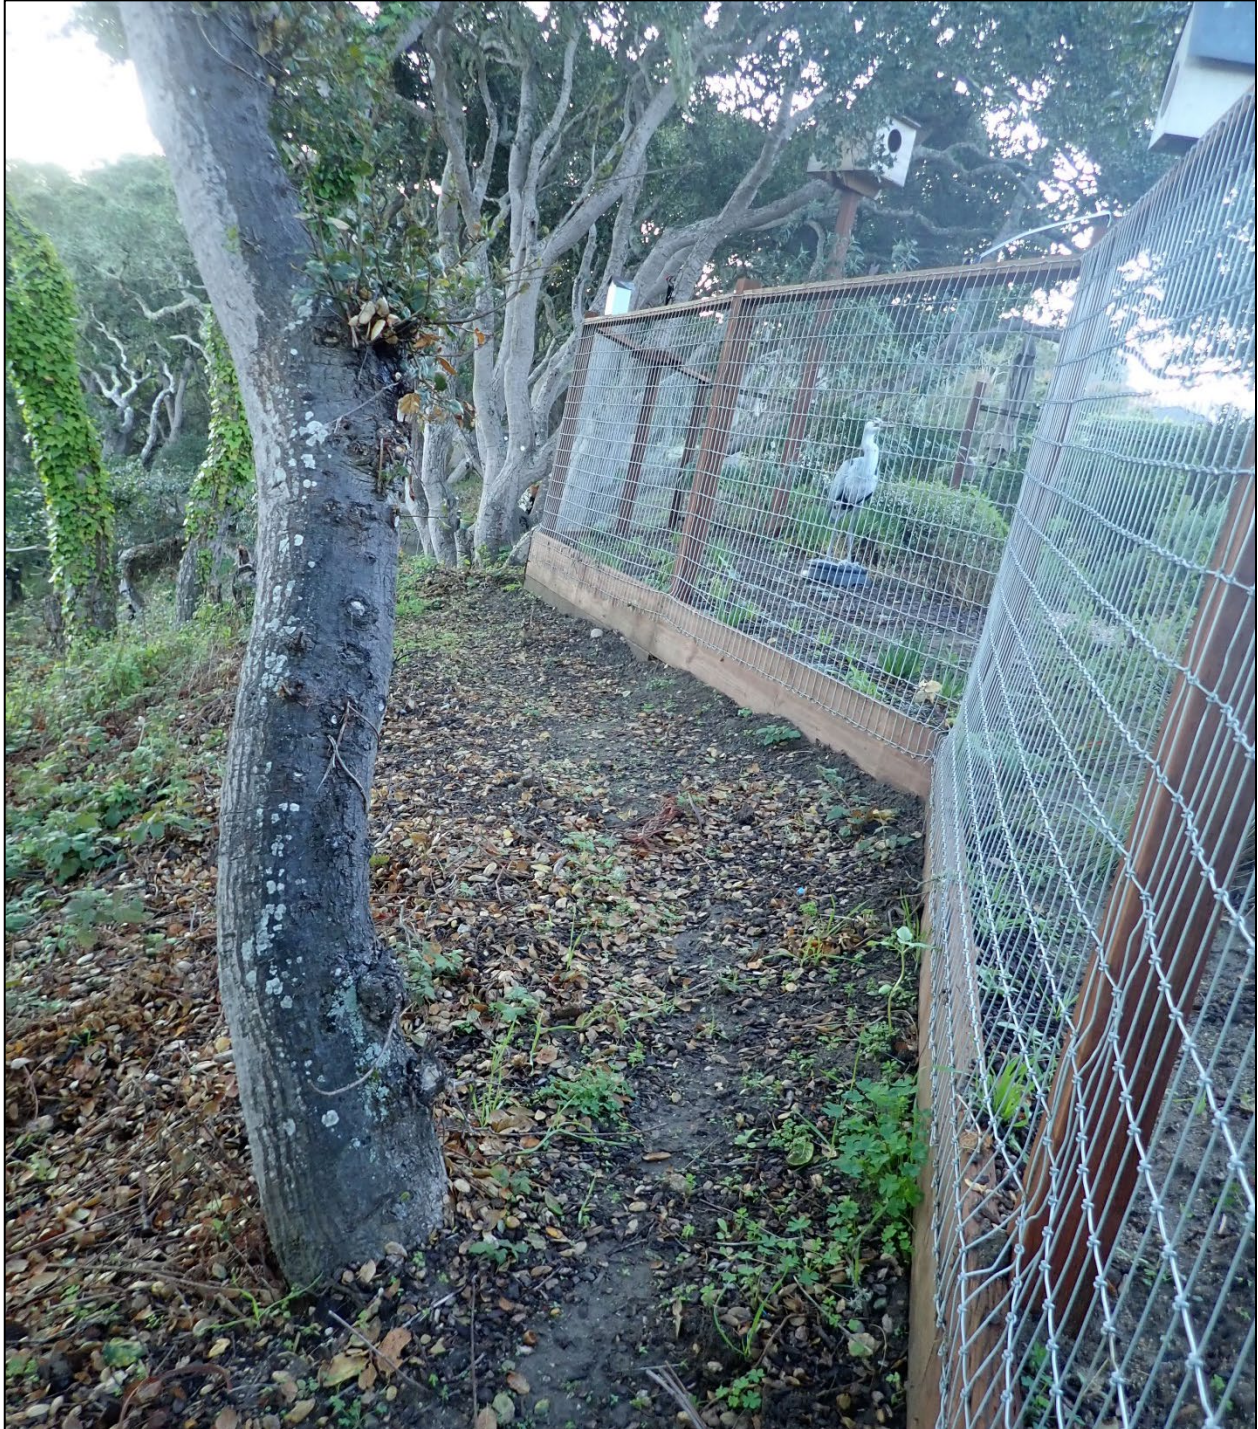
**Photograph 2.** Protected trees #429 - #437 behind 2805 Ribera Road. These trees are on a slope at the northeastern edge of the Study Area.

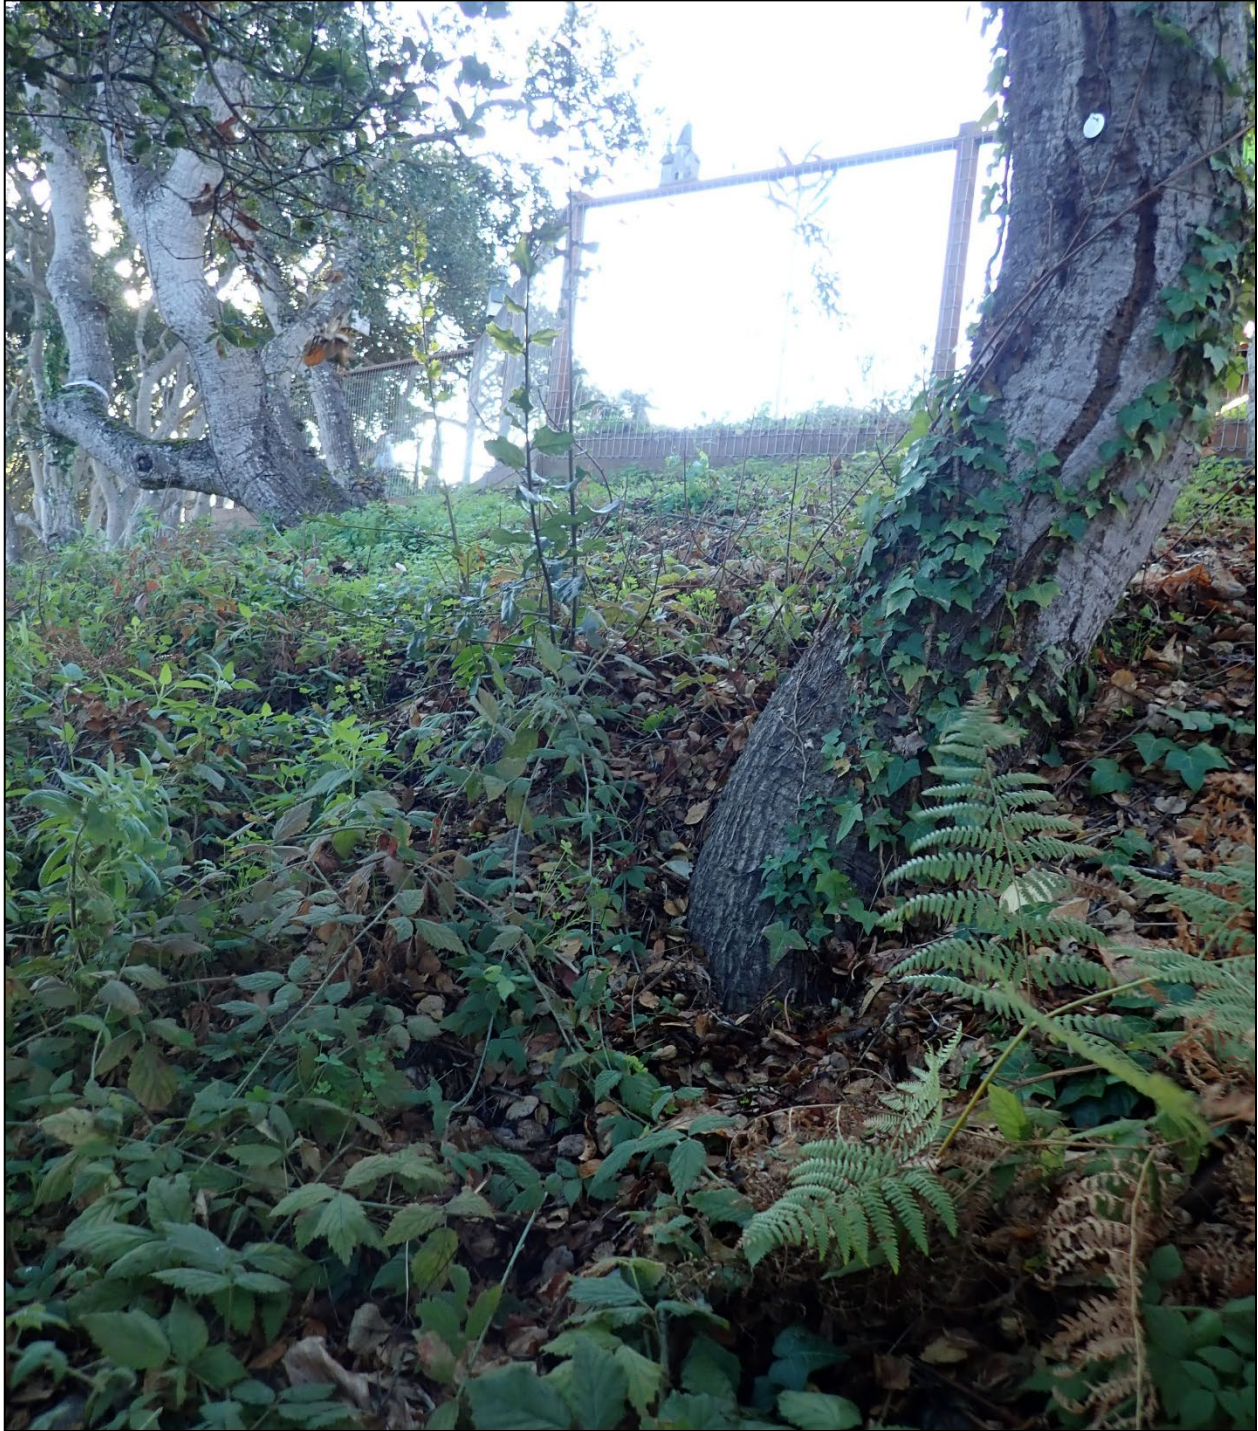
**Photograph 3.** Trees on a slope and above manhole to be cleaned out between addresses 2805 and 2795 Ribera Road.

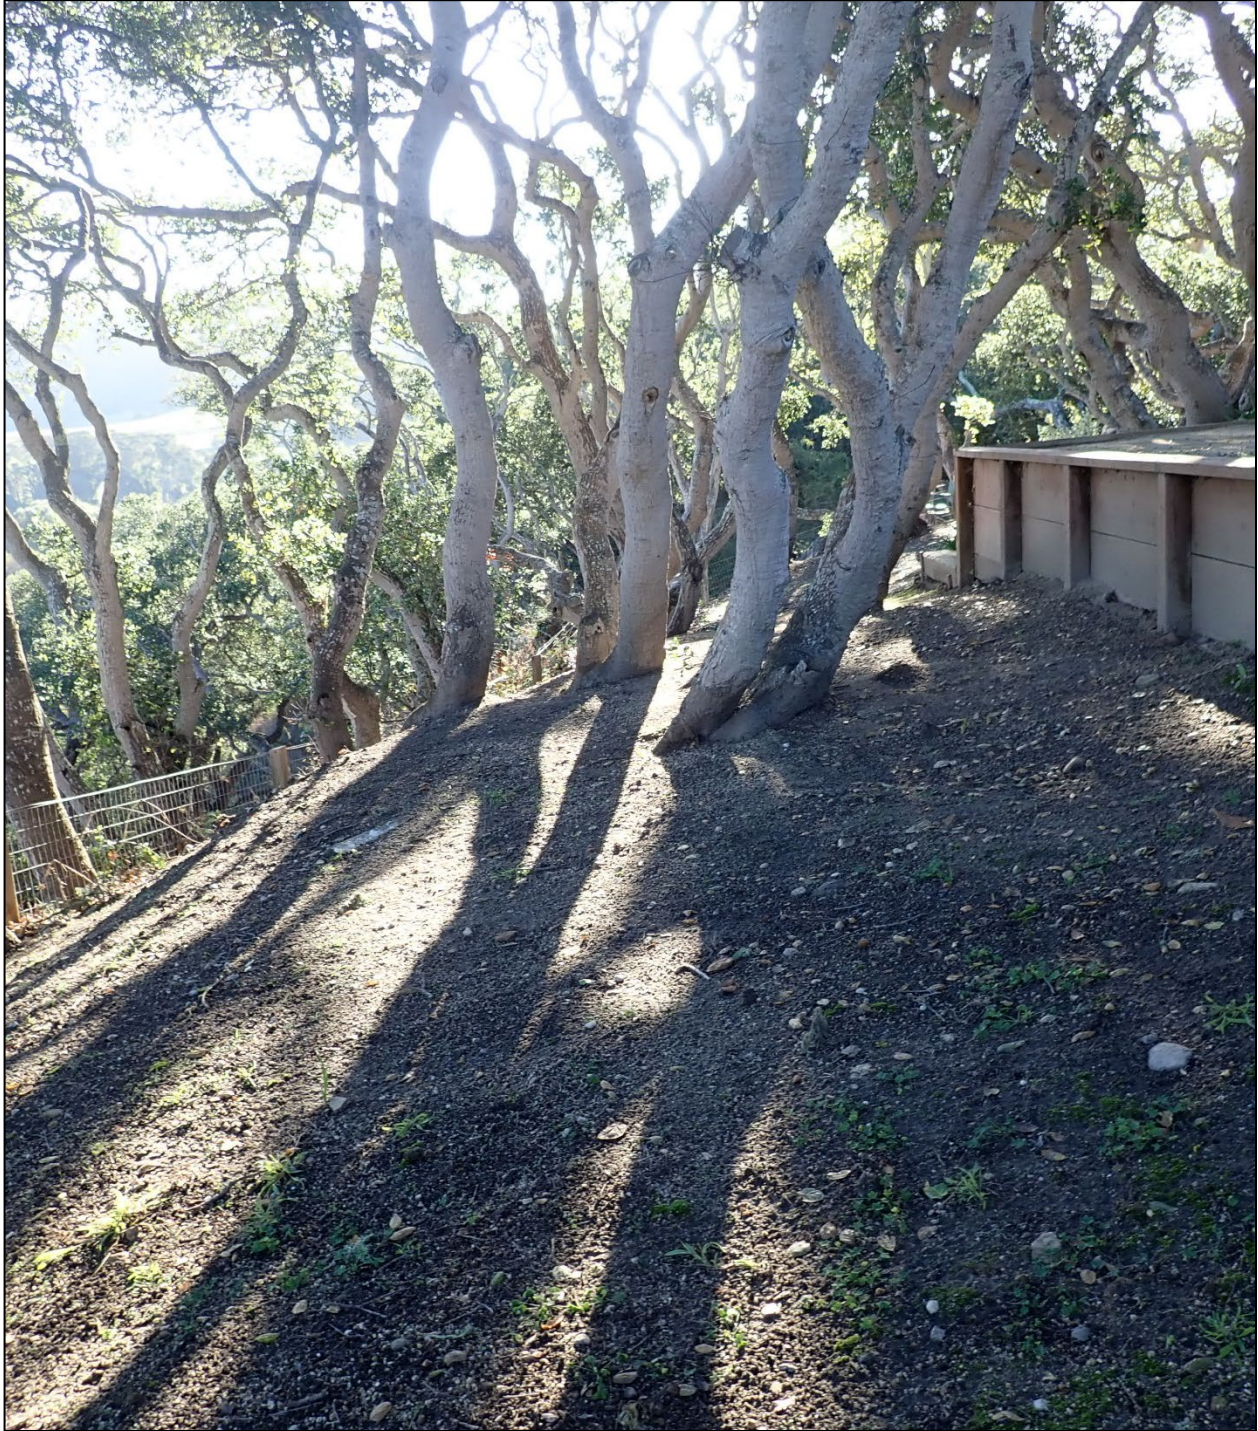
**Photograph 4.** Trees #460 - #470 , all protected coast live oaks, behind 2785 Ribera Road within the Study Area. These trees are along proposed replacement sewer pipeline alignment.

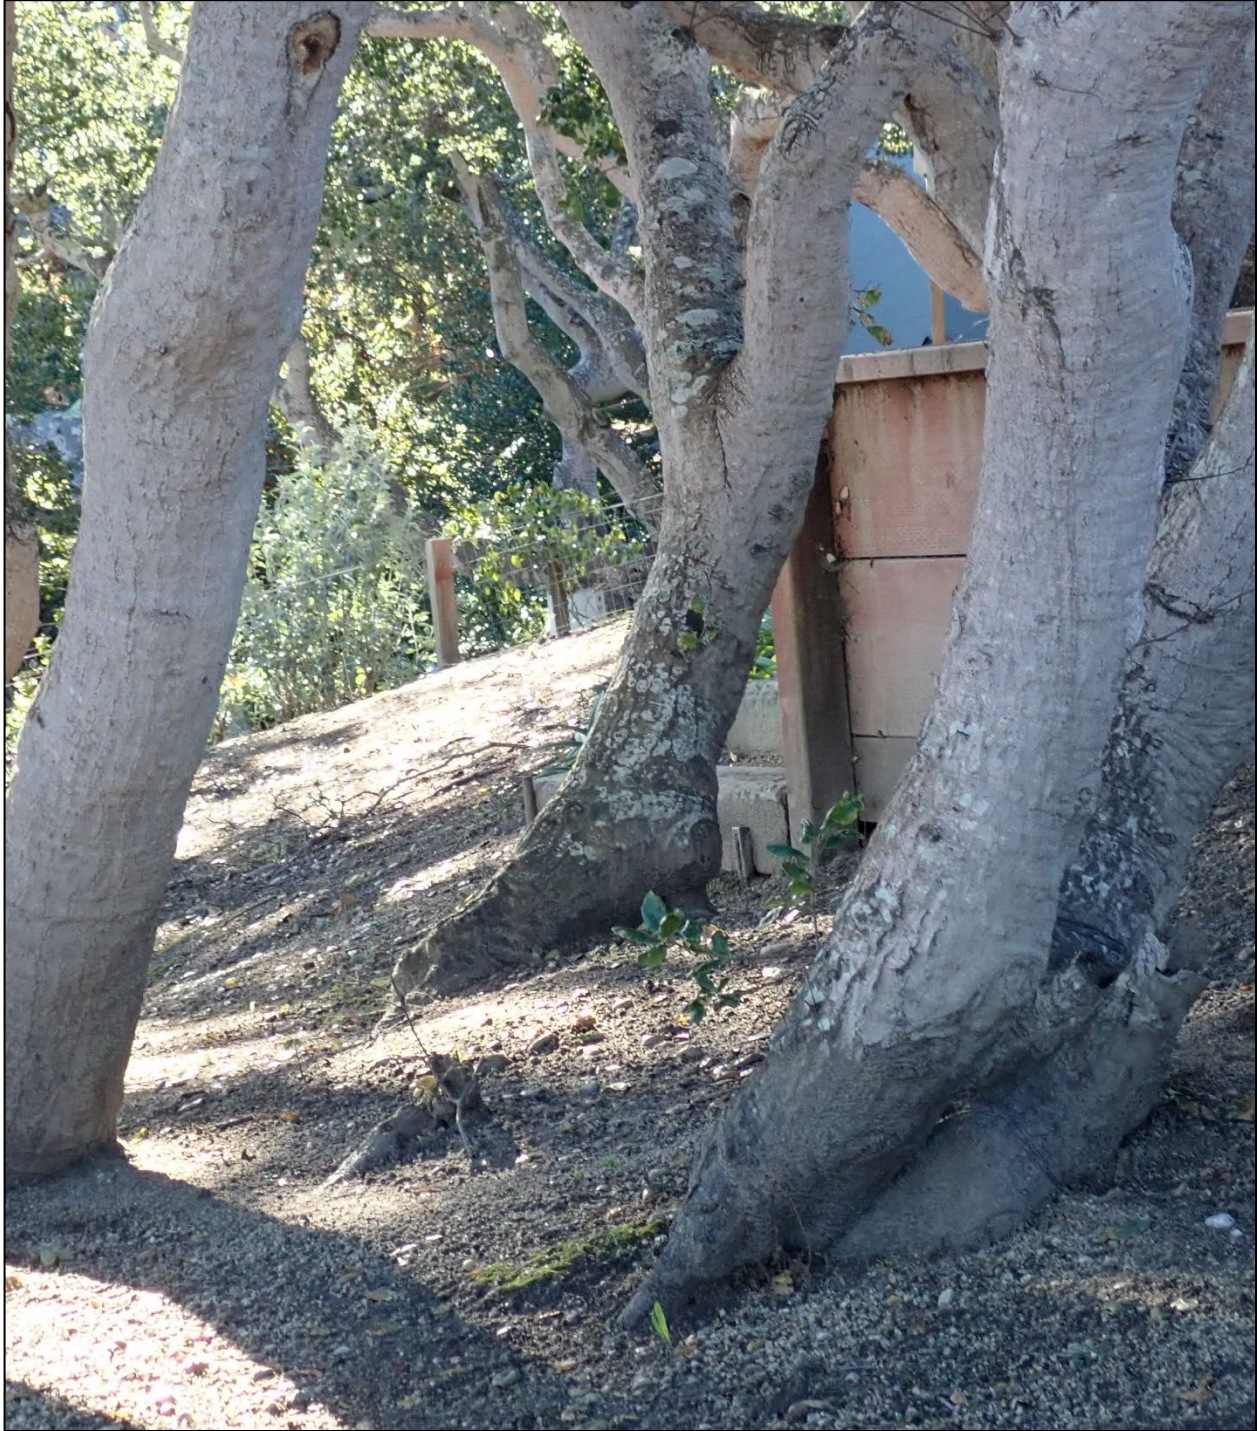
**Photograph 5.** Trees #468 - #470, all protected coast live oaks, behind 2785 Ribera Road within the Study Area along proposed replacement sewer pipeline alignment.
