**FINAL
INITIAL STUDY/
MITIGATED NEGATIVE DECLARATION
for
HATTON CANYON
SEWER REPLACEMENT PROJECT**

CARMEL AREA WASTEWATER DISTRICT

October 2018

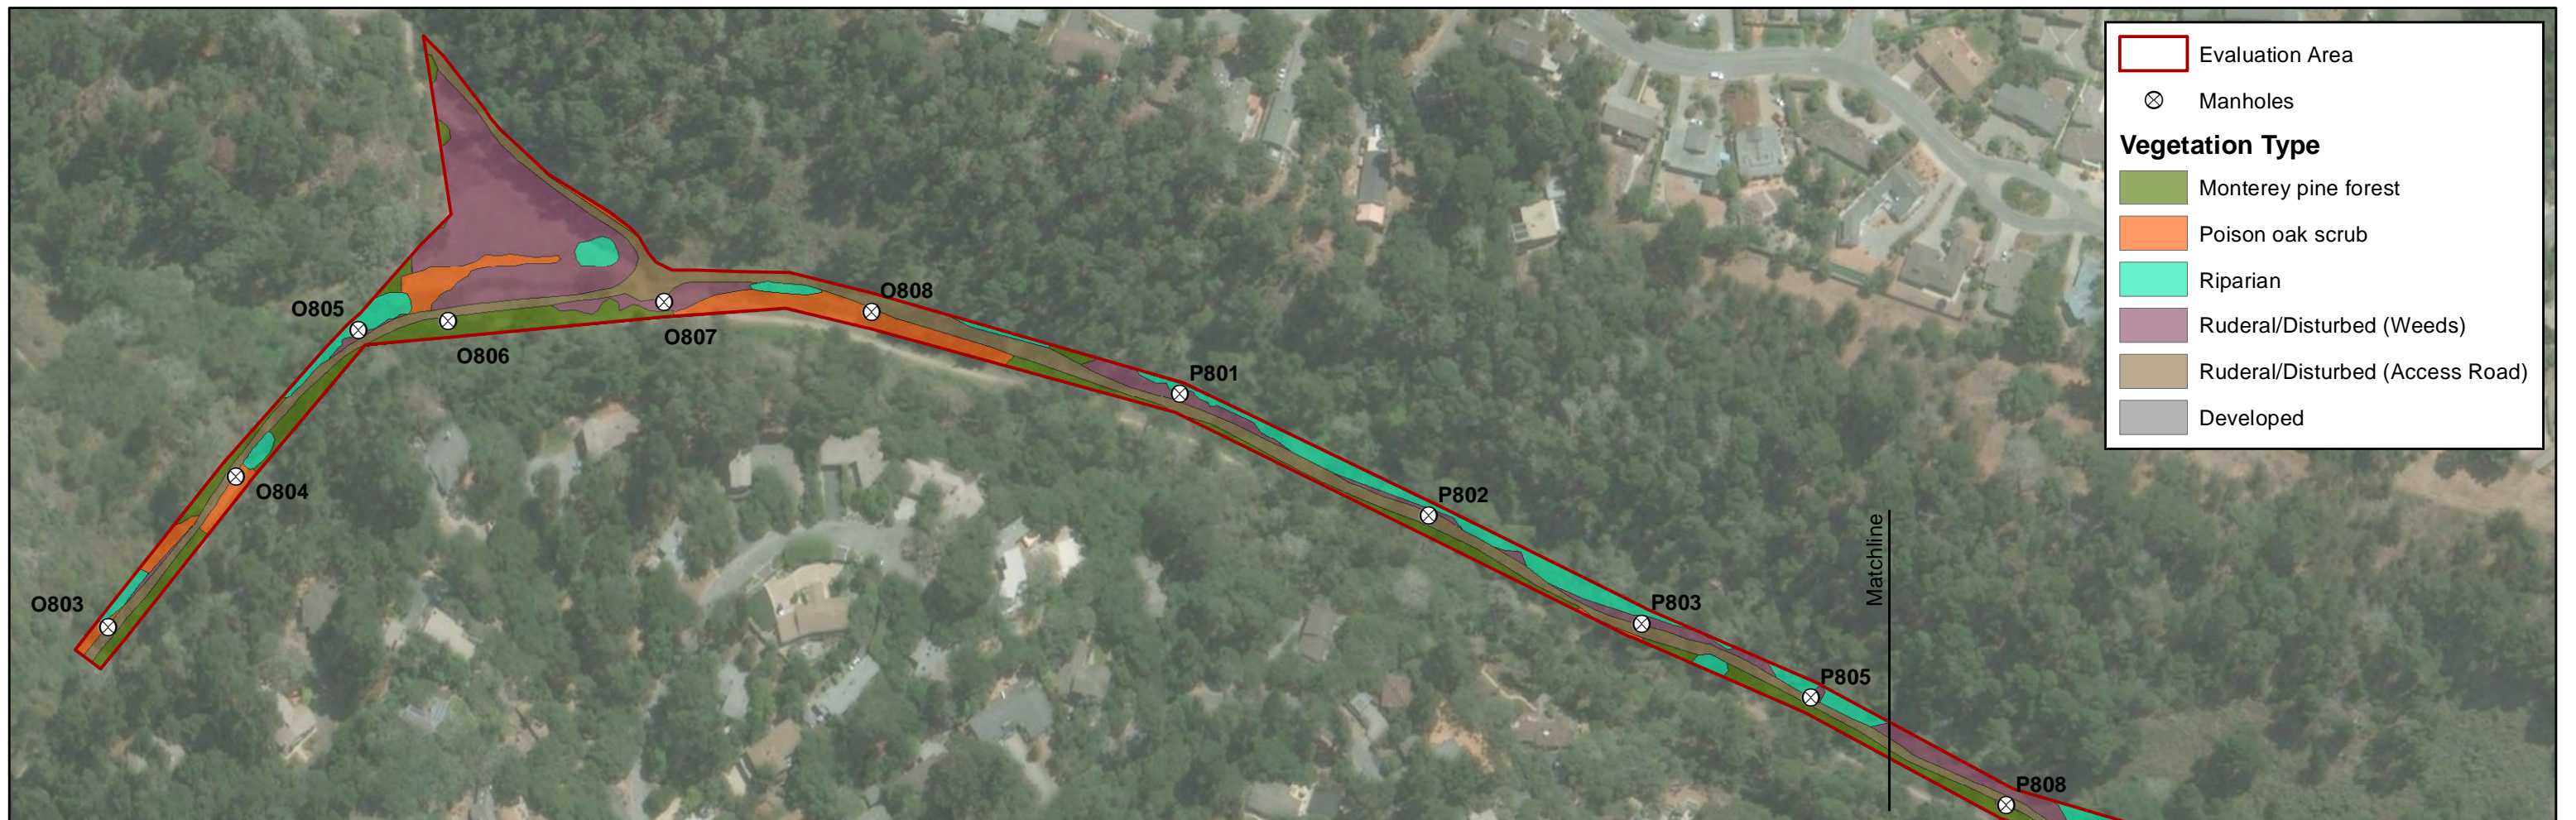
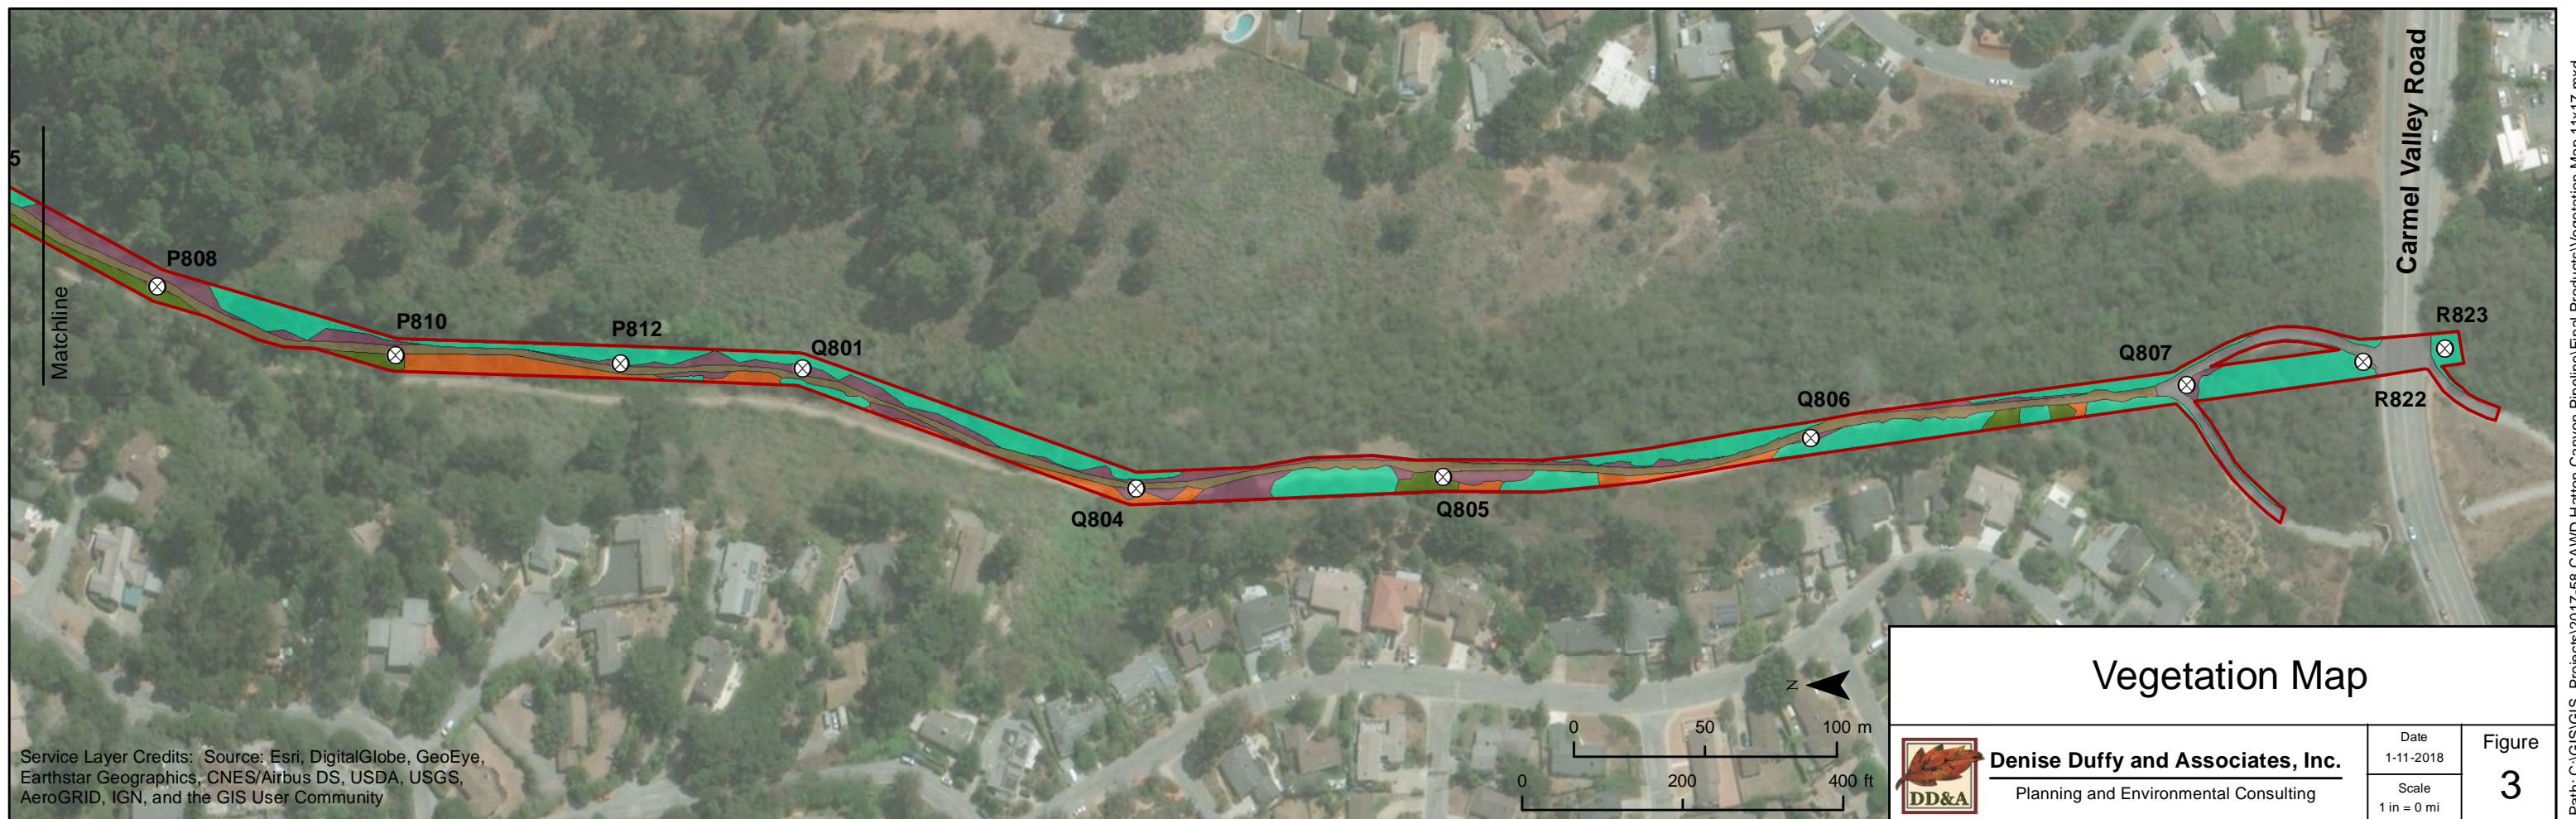
Vegetation Map

Evaluation Area
	Manholes
Vegetation Type	
	Monterey pine forest
	Poison oak scrub
	Riparian
	Ruderal/Disturbed (Weeds)
	Ruderal/Disturbed (Access Road)
	Developed
