**CARMEL AREA WASTEWATER DISTRICT**

# Wastewater Collection System Asset Management Plan

**DECEMBER 2018**

Project No. 683-21-17-03

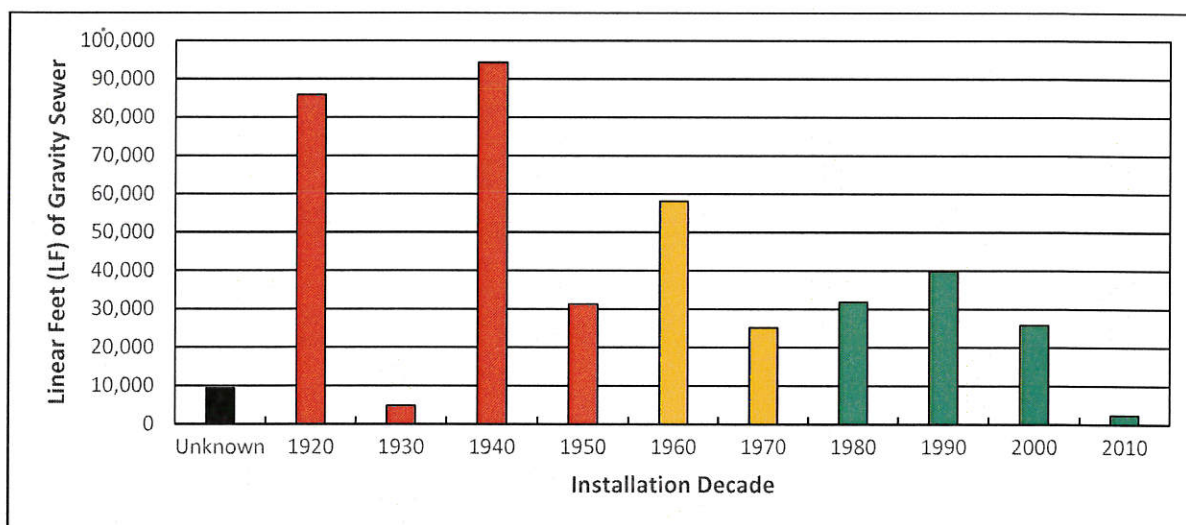
**Figure 2. Gravity Main Asset Age**

VCP sewers installed before 1958 (shown in red on Figure 2) have short lengths (therefore, numerous joints) with cement mortar joints, which shrink and crack and allow much higher rates of infiltration and root intrusion<sup>1</sup> than post-1958 sewers that use rubber-gasket joints. While VCP

Figure 2 shows the installation decade of the gravity sewers in the collection system. The average gravity sewer age in the system as a whole is 59-years, indicating that a significant portion of the system is nearing the end of its useful life.

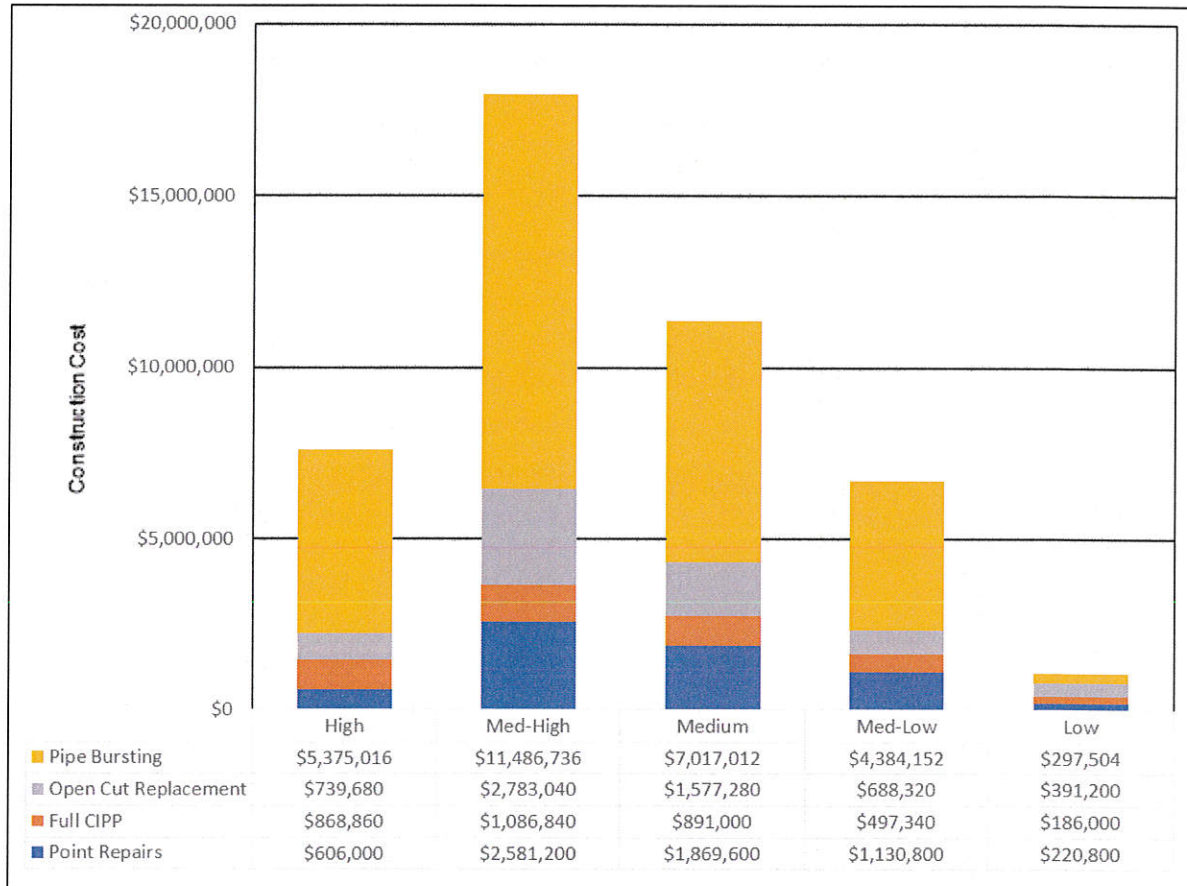
**Figure 13. System-Wide Rehab/Replacement Needs by Construction Method**

The rehab/replacement strategy and unit costs described above were applied to each individual gravity sewer and its PACP-coded defects, and the rehab/replacement needs shown in Figure 13 were identified. Figure 13 shows rehab/replacement construction cost estimates by risk level and construction method. Table 8 shows the system-wide rehab/replacement needs by risk level and capital cost.

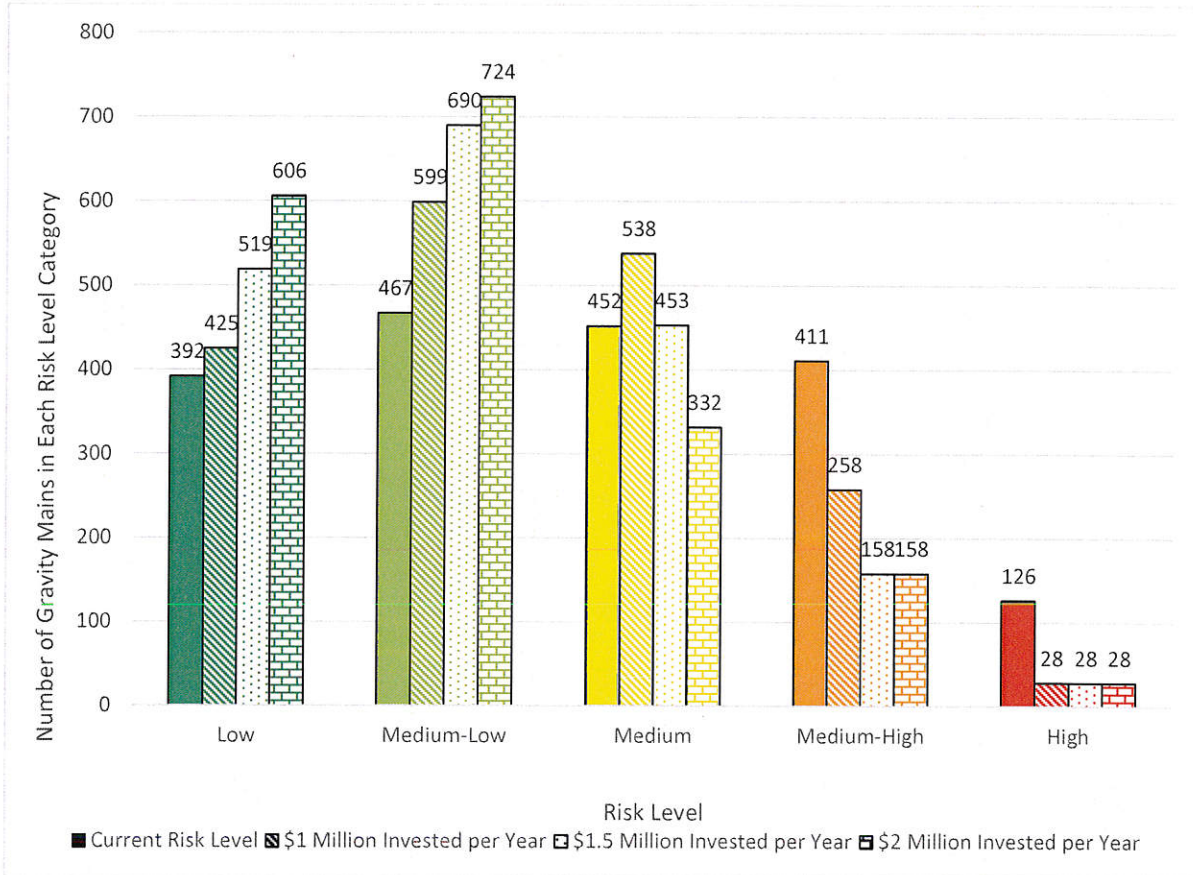
**Figure 14. Risk Level of All Pipes After 20-Year Rehab/Replacement Program Options**

In recent years, the District has invested approximately \$750,000 per year (in construction costs) in collection system rehab/replacement projects. As discussed previously in this report, an increase in the level of investment is warranted due to the age and condition of the system. Figure 14 and Table 9 explore new annual investment strategies: \$1M/year, \$1.5M/year, and \$2M/year. Figure 14 shows the current risk level of the system (in solids bars) and compares that to the risk level of the system after a 20-year rehab/replacement program at each of the three annual investment strategy scenarios. Figure 14 also shows the impacts to the existing system risk levels under each scenario improvements are made. It should be noted that under the \$1M/year investment option, it takes nearly 26-years to complete the existing backlog of high and medium-high risk repair projects.
