Carmel Area Wastewater District

Data Science Services for Collection
System Gravity Main Cleaning
Optimization

**DATA ASSESSMENT
TASKS 1-8**

**ANALYTICS AND IMPLEMENTATION
TASKS 9-11**

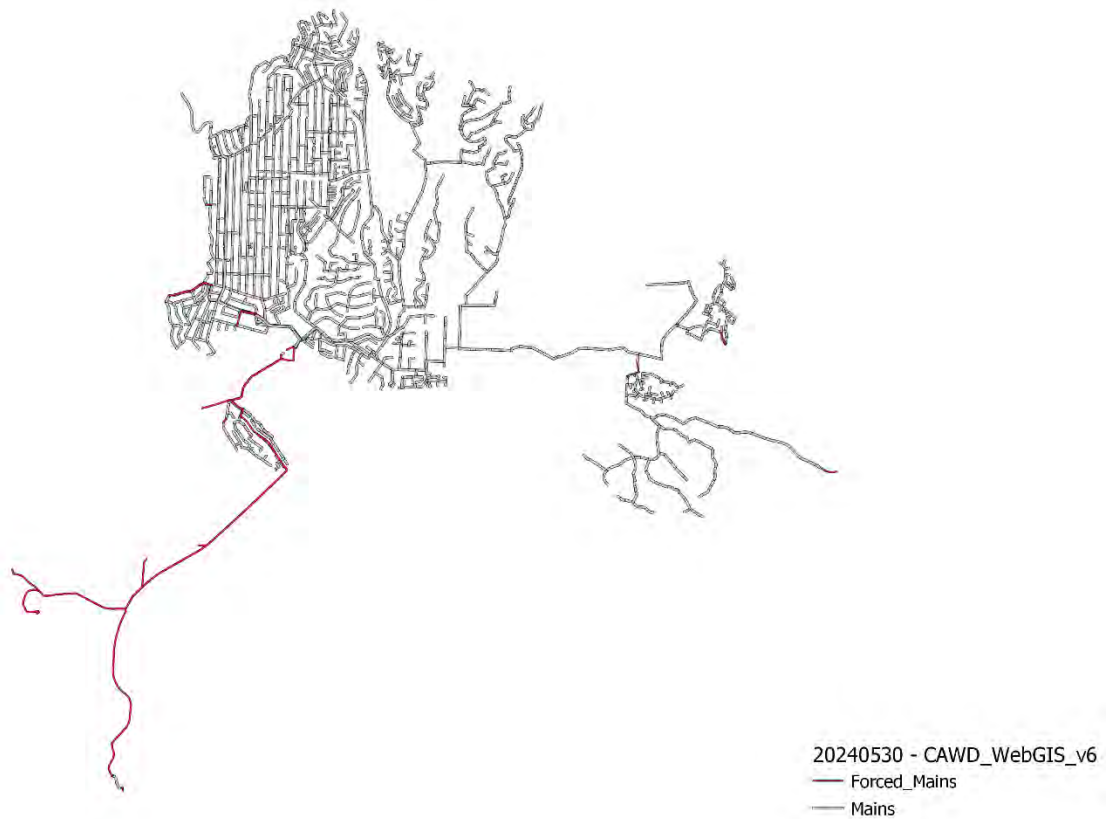
Figure 1-1: Map of Carmel collection system.

- Source: CAWD_WebGIS_v6.gdb (GeoDataBase)
 - File type: GeoDataBase
 - Received on: 5/30/2024
 - *Active_Assets*: 2,006 manholes
 - *Force_Mains*: 34 for mains (8 miles)
 - *Mains*: 1,960 gravity mains (84 miles)

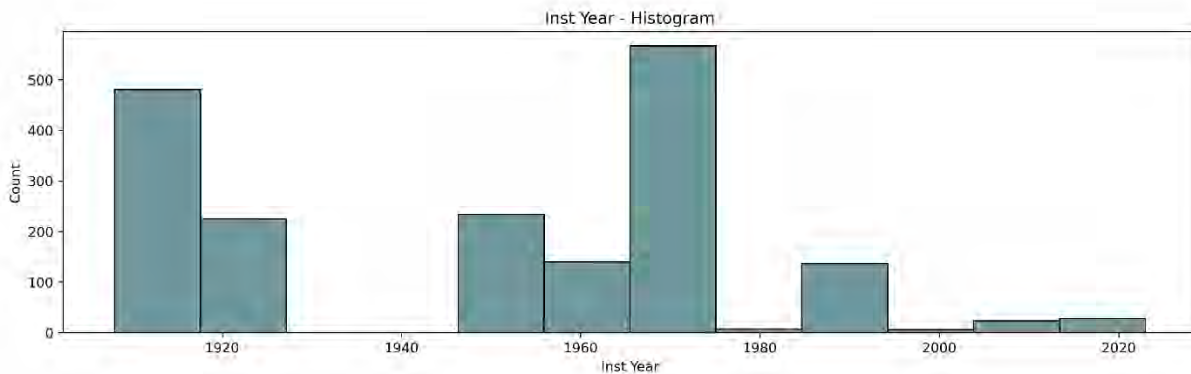
Figure 1-2: Gravity main segment installation years, count histogram.

The breakdown of gravity main segment installation years and materials are summarized below:

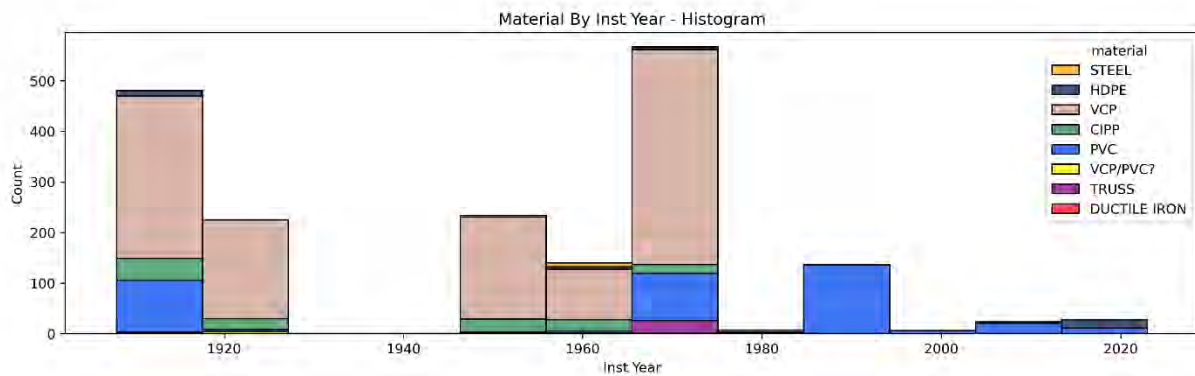
Figure 1-4: Gravity main segment installation years and materials, count histogram.

- **Summary:** the PVC pipes installed prior to 1910 are suspicious

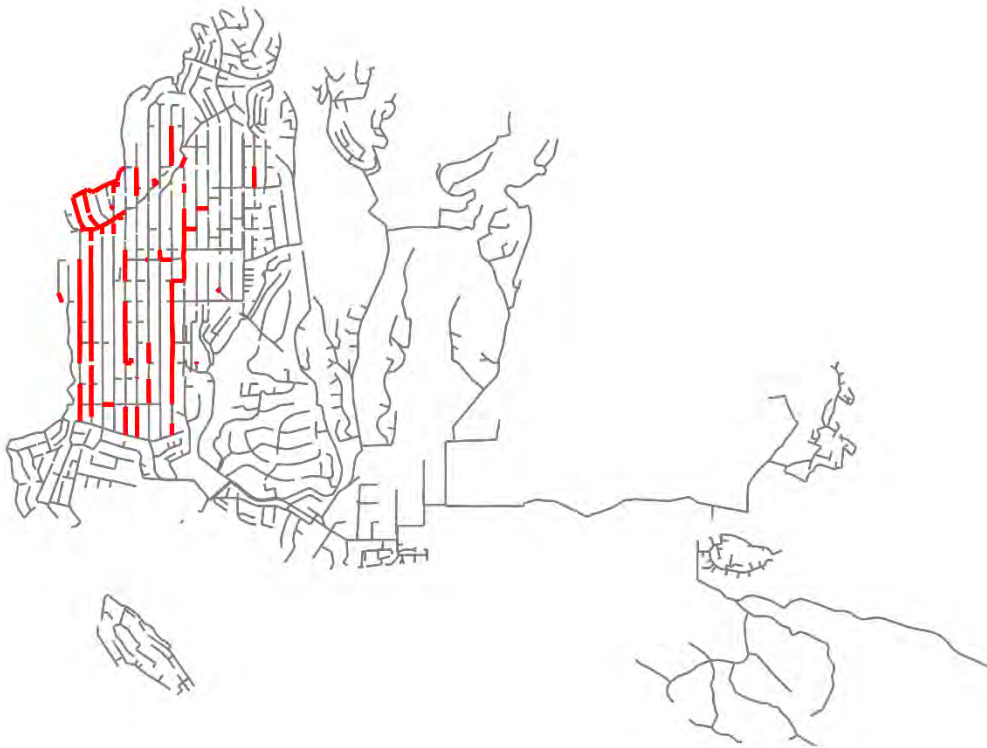
Figure 1-5: Map of PVC segments installed prior to 1920.

The following 103 PVC gravity main segments showed installation years as 1908—since the earliest *possible* installation year for PVC is around 1920, these will be assumed to be from 1985 (per discussion with CAWD 7/9/2024).

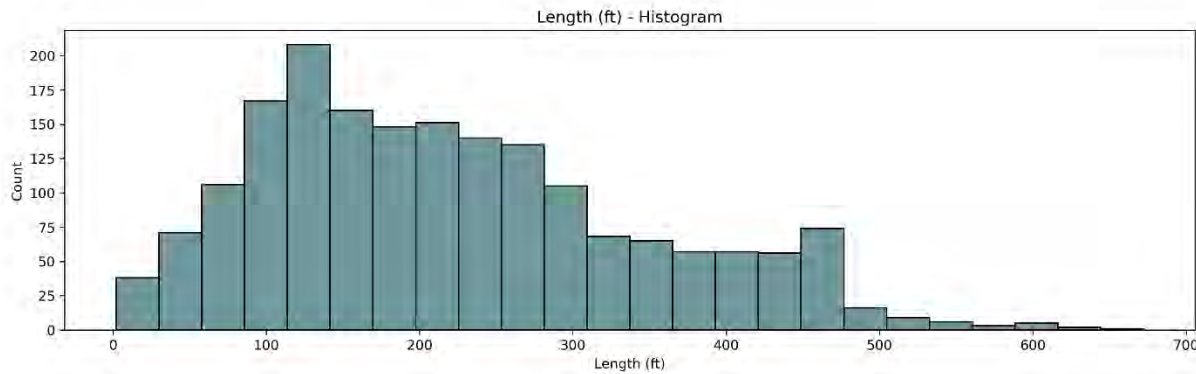
Figure 1-7: Histogram on gravity main segment lengths, by count.

- There are no segments with Null value for length
- Mean segment length: 221 feet
- Total length:
 - Raw file: 83.30 miles
 - Processed file: 77.57 miles operated and maintained

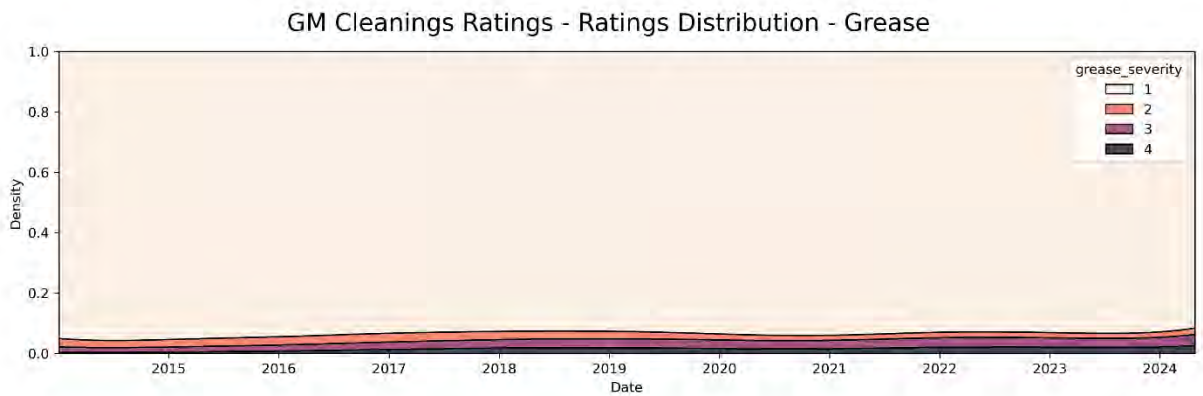
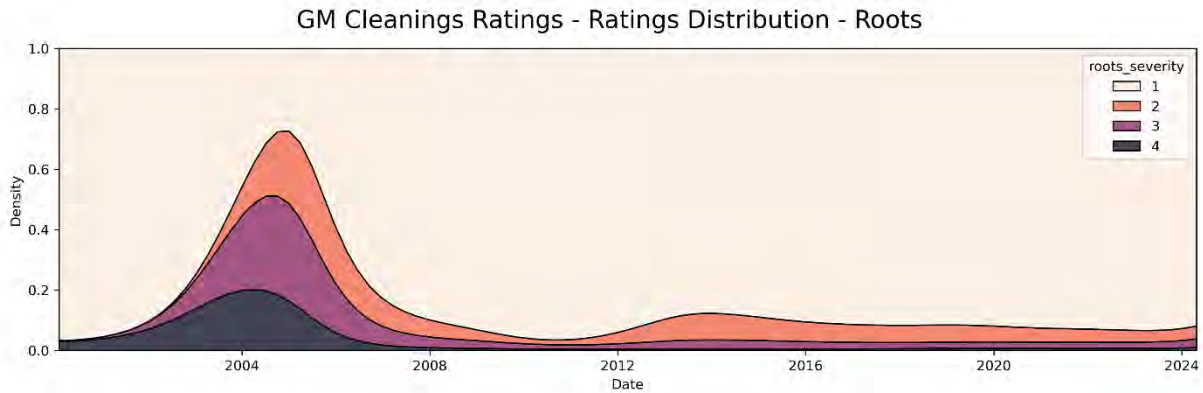
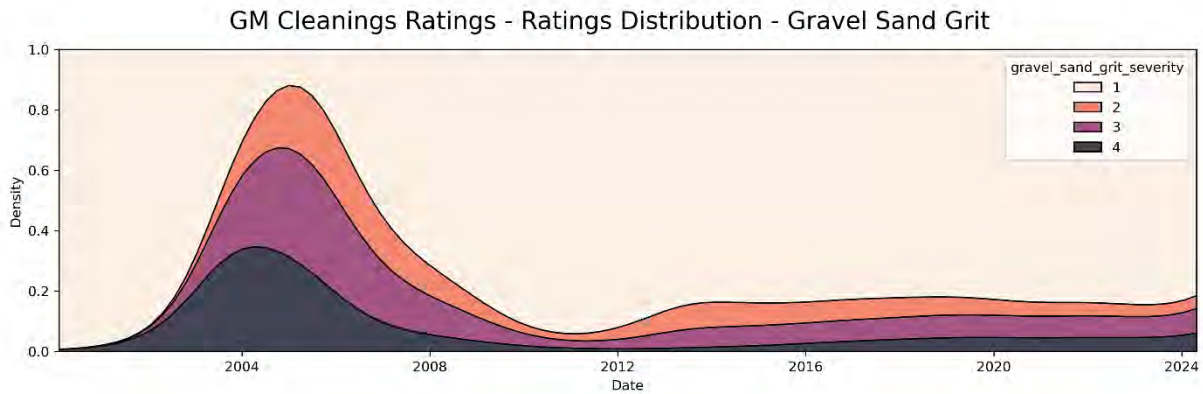
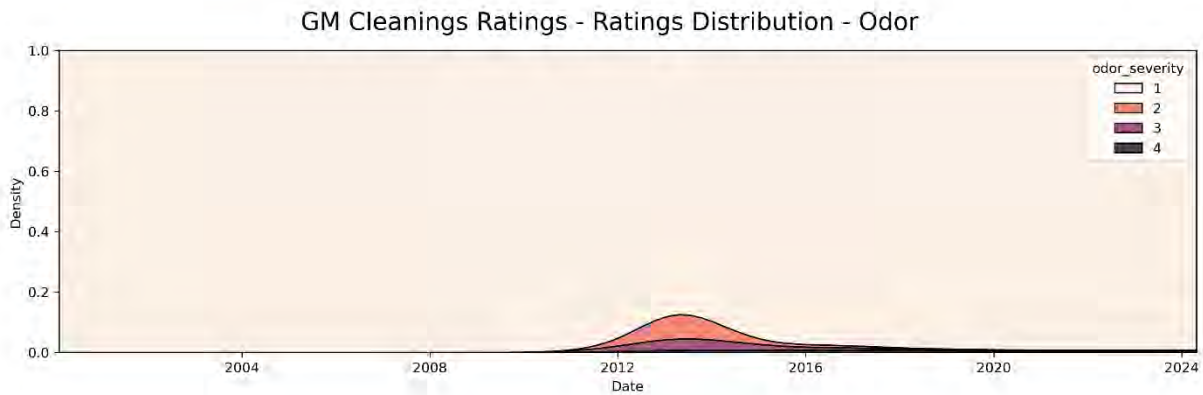
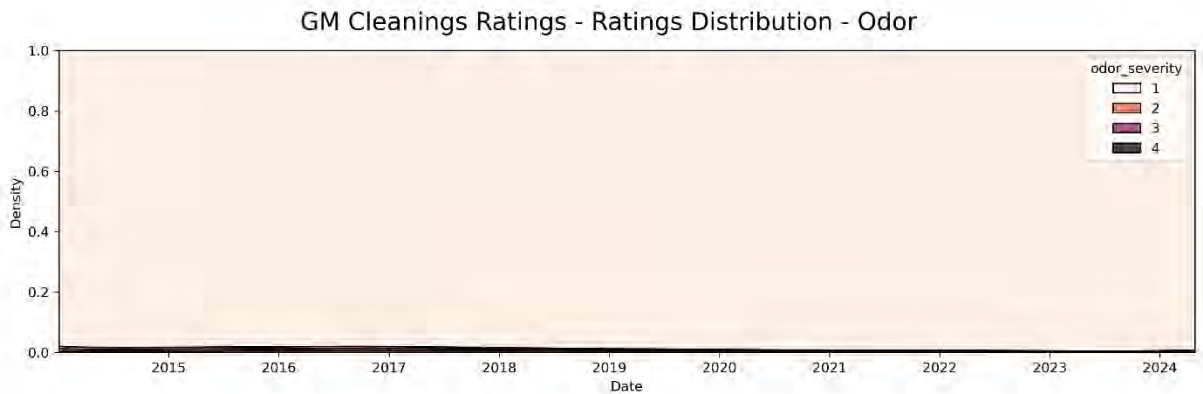
Conclusion: the cleaning condition data is the MOST consistent since 2014, and quantity of data prior to 2014 is very limited. Therefore, only records from 2014 will be considered for detailed predictions.

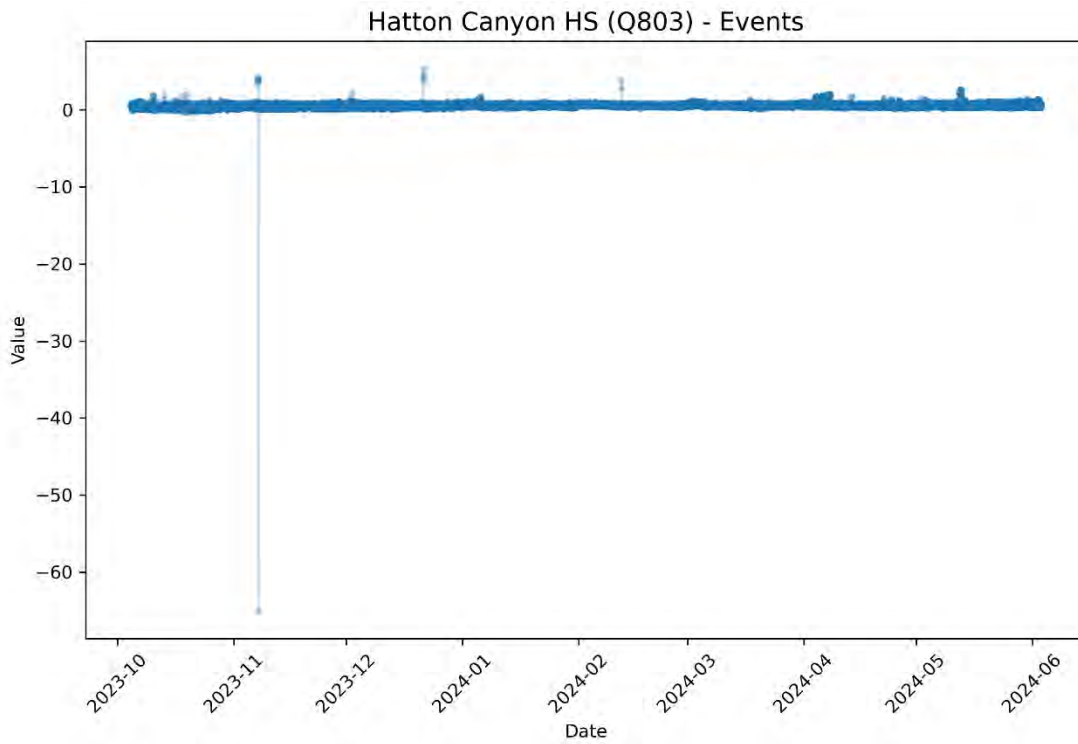
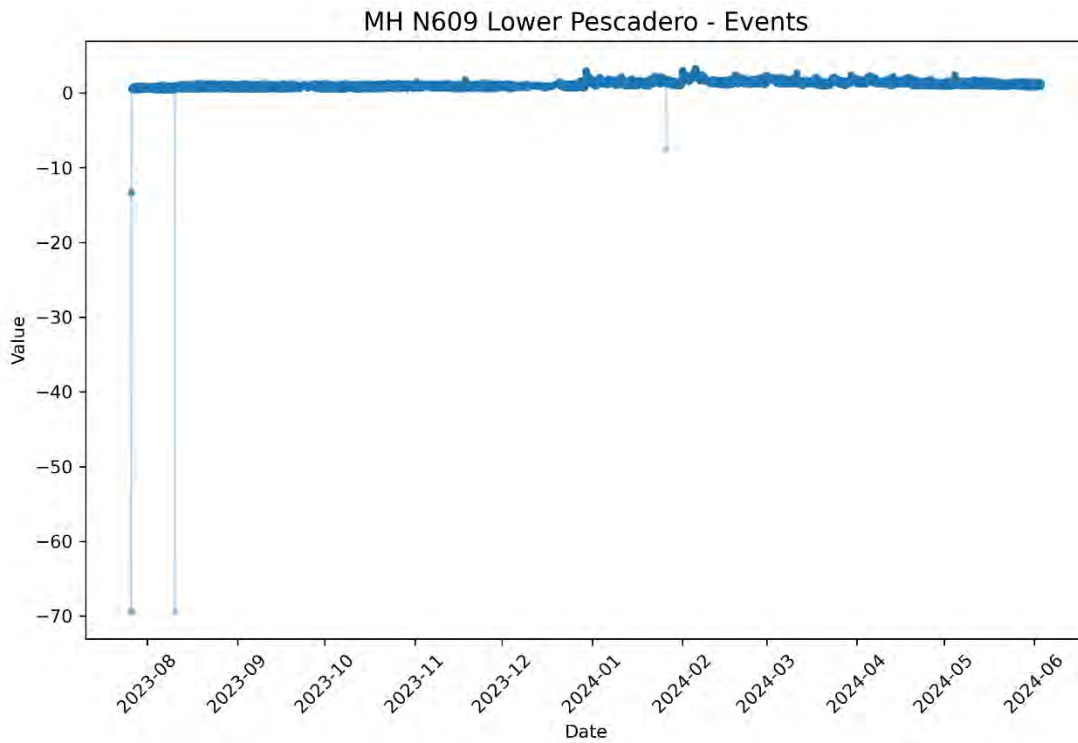
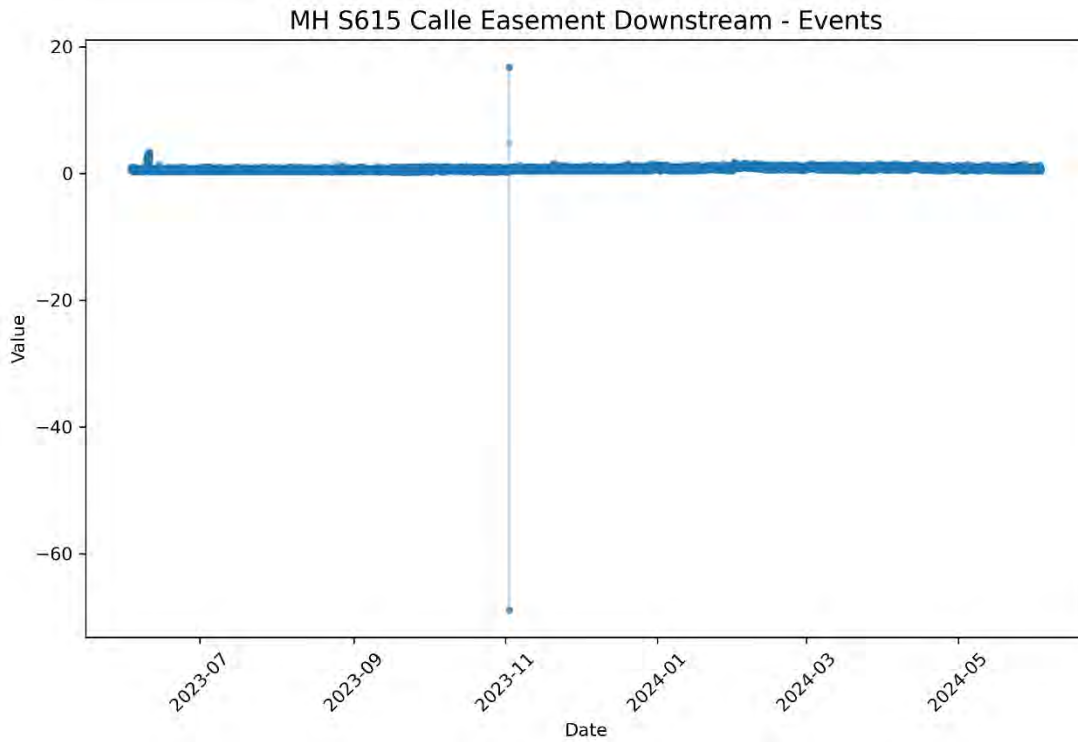
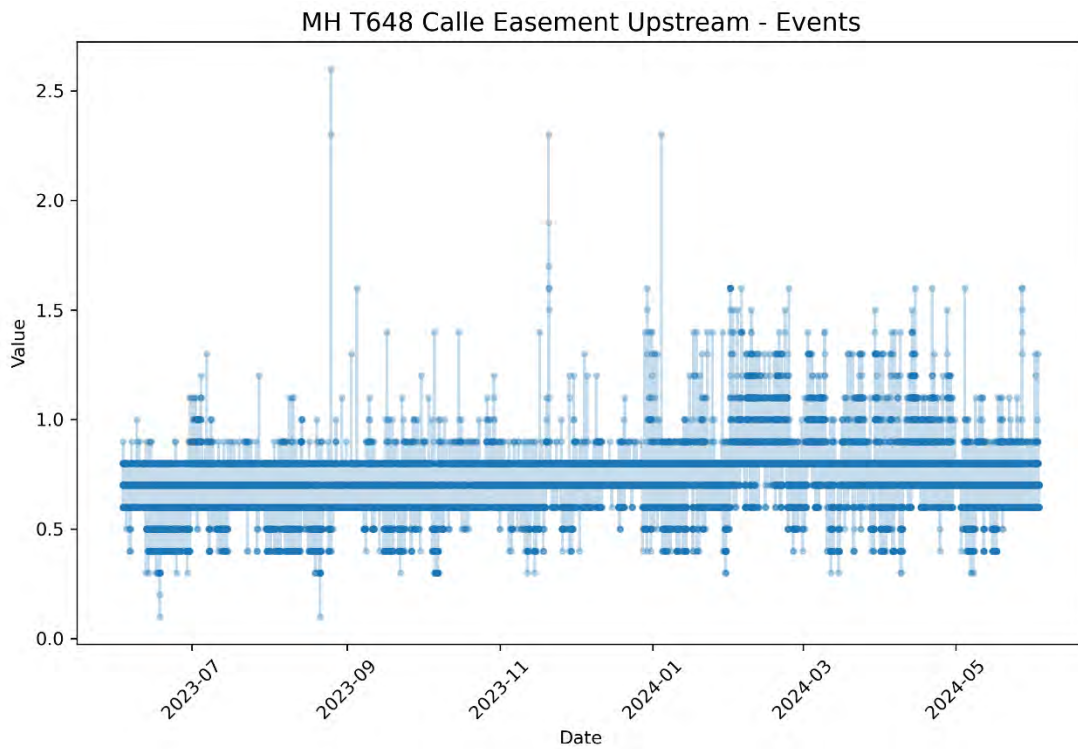
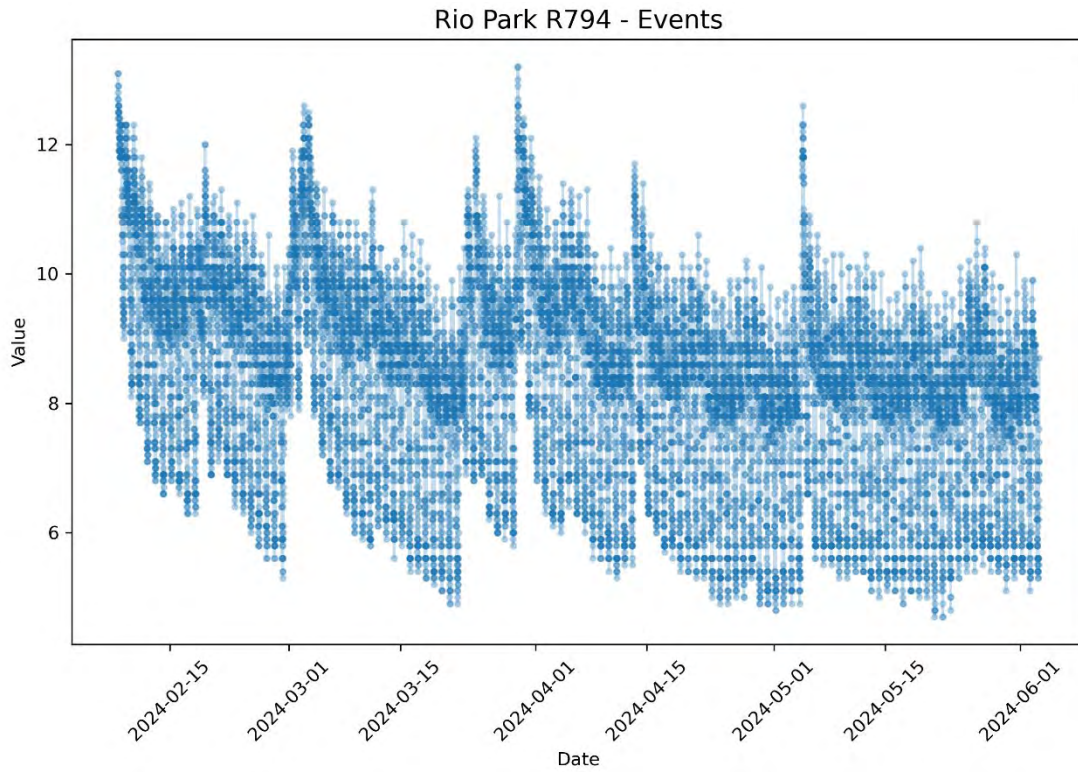
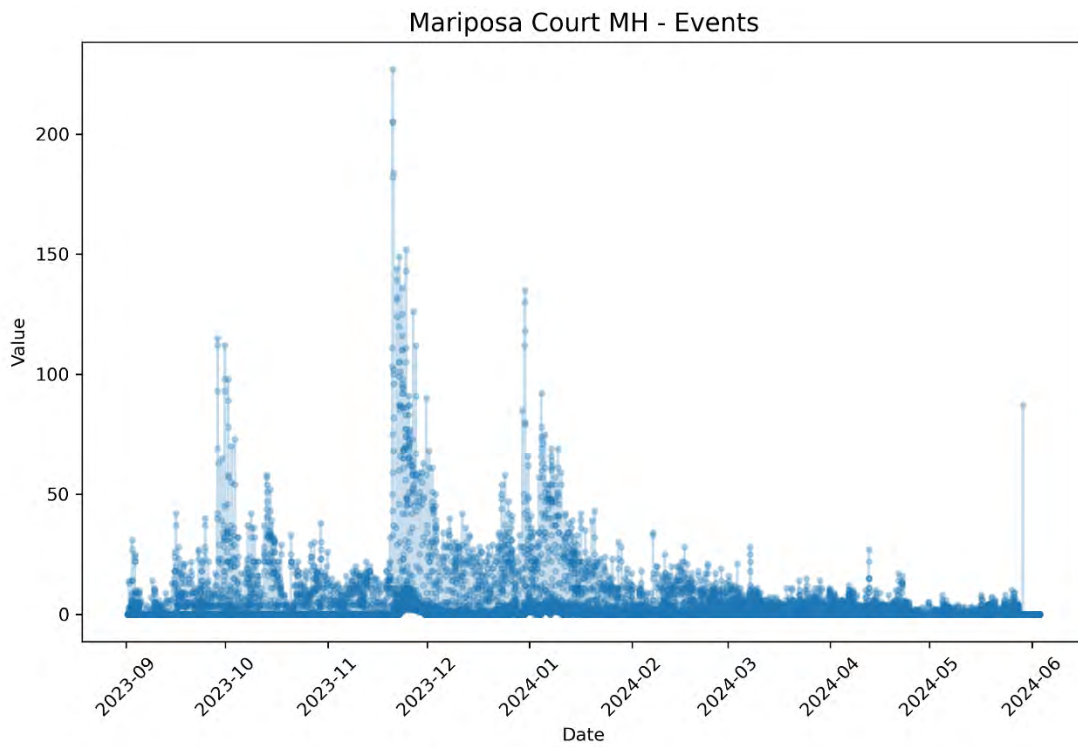
Level ranges for each SmartCover sensor in the time period are as follows:

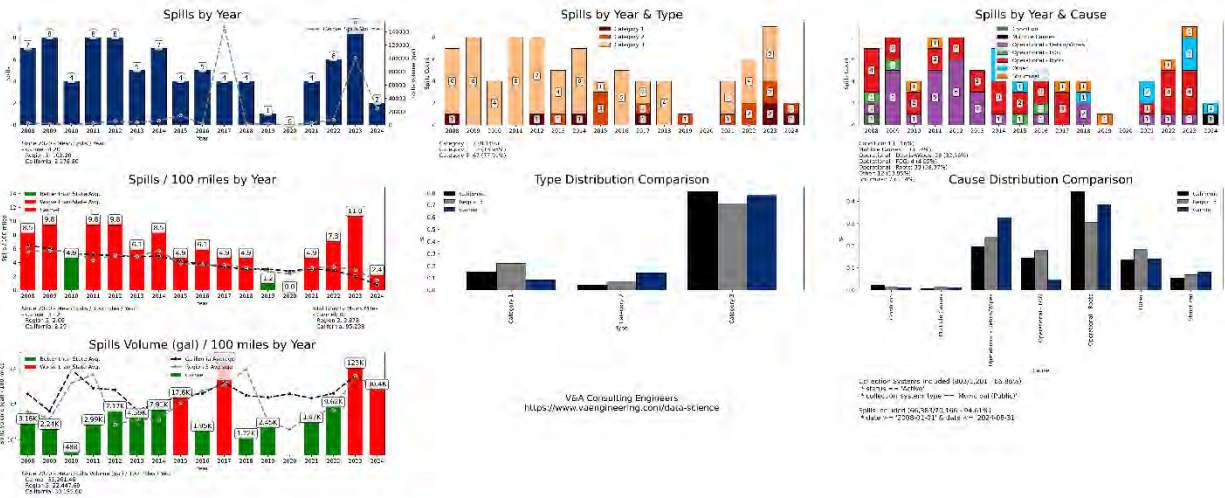
Figure 1-32: CAWD all sewer spills through 8/31/2024.

The most recent spill occurred on 8/5/2024:

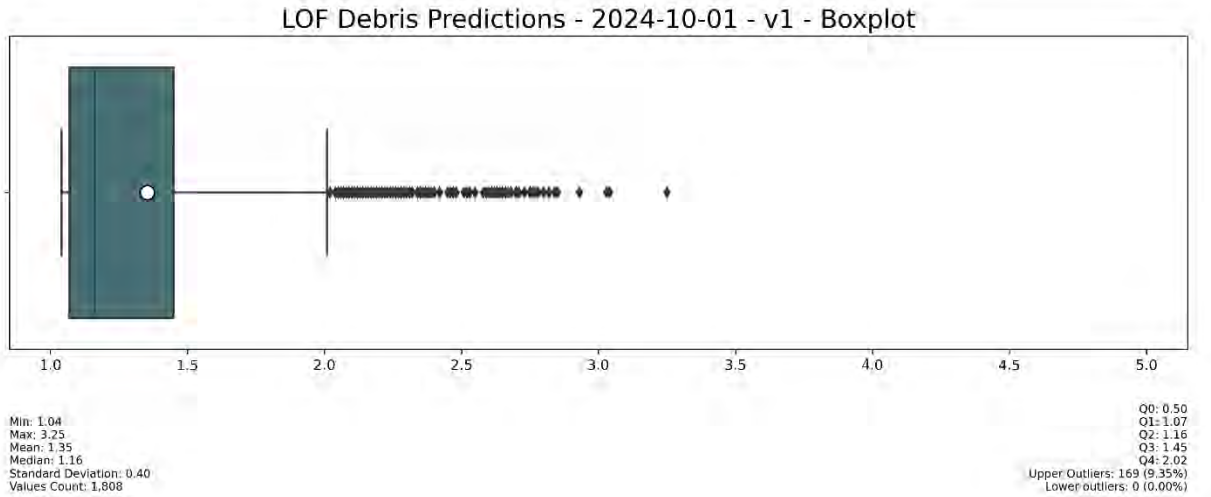
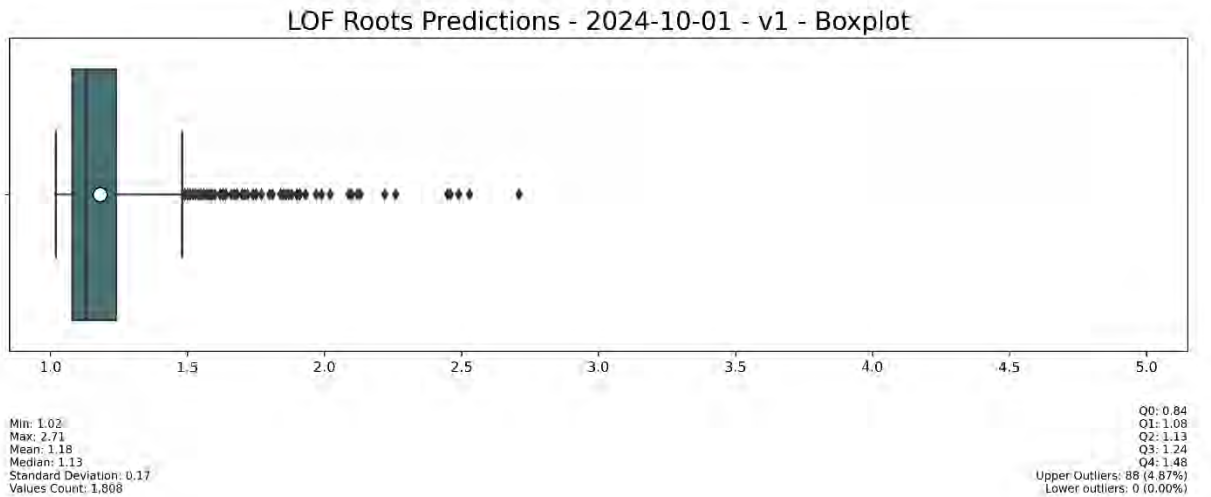
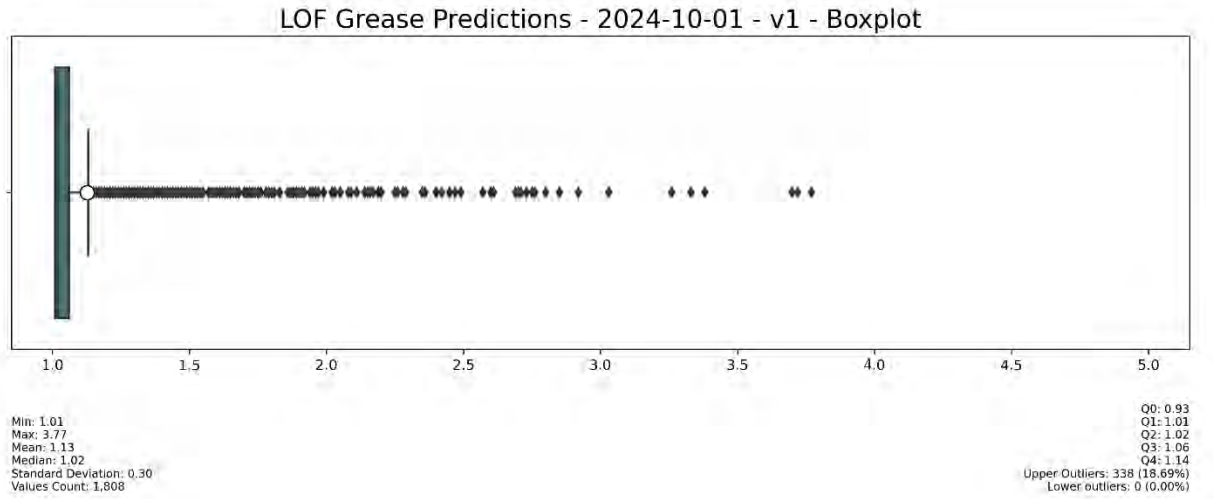
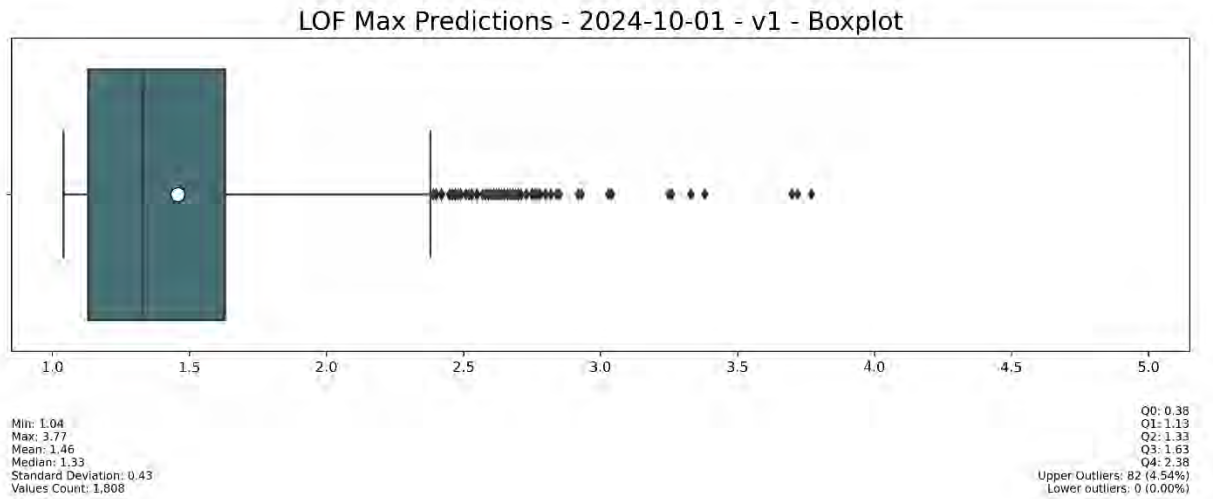
Box plot distributions for grease, roots and debris are shown here. These will be further analyzed for specific segment recommendations in section 3 (task 10).
